Report No: RG/2007/08/19/1

Date: January 2008

## **Soil, Land Capability and Land Use Assessment Proposed Valencia Uranium Mine**

**Rehab Green Monitoring Consultants CC**

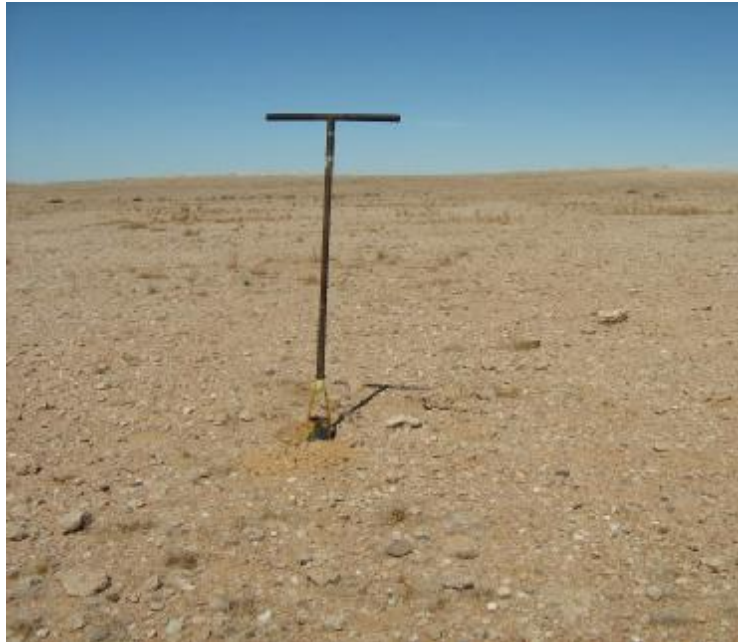
Soil unit **Cg** consists of flat to gently sloping plains with scattered stones (50-150mm) on the surface and comprises 3.74% of the surveyed area. These are shallow soils (50-250 mm) underlain by hardpan carbonate dominated by the Coega form (see Figure 12 for sampling and photo points).

**Figure 2: Photo taken at soil unit Cg, sampling point AK22**

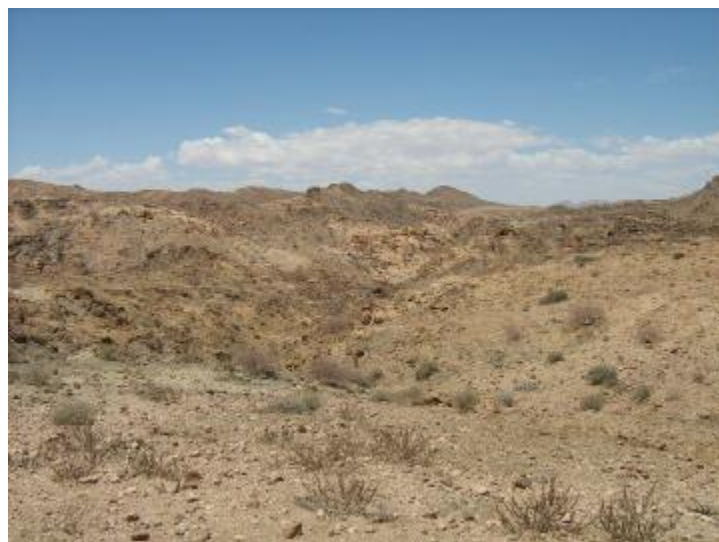
Soil unit **Gra1** consists of very steep, undulating granite outcrops with 60-80% exposed surface stone and rock and comprises 21% of the surveyed area. These are shallow soils (50-100 mm) underlain by hard or slight weathered rock dominated by the Mispah form.

**Figure 3: Photo taken at soil unit Gra1, photo point BL19**

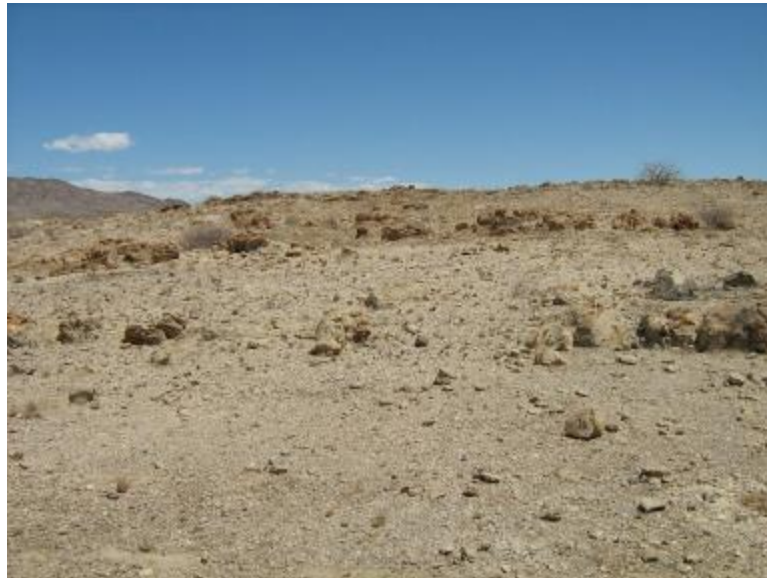
Soil unit **Gra2** consists of steep to mild rolling granite outcrops with 5-20% exposed surface rock and comprises 8.63% of the surveyed area. The soil surface is mostly covered with a thin layer (30mm) of quartzite gravel. These are shallow soils (50-100 mm) underlain by hard or slightly weathered rock of the Mispah form.

**Figure 4: Photo taken at soil unit GRa2, sampling point BF17**

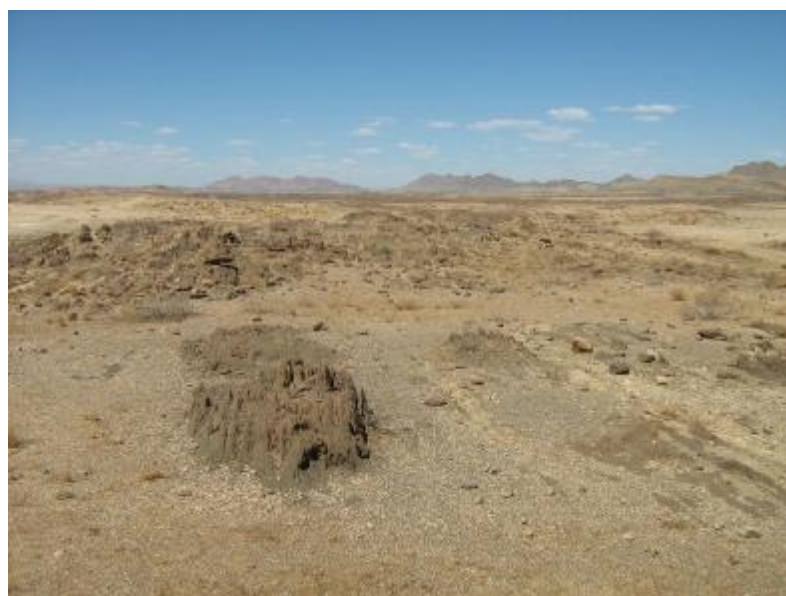
Soil unit **Gra3** consists of mild rolling granite outcrops with frequent linear schist bands with 10-50% exposed surface rock and comprises 8.82% of the surveyed area. The soil surface is mostly covered with a thin layer (30mm) of quartzite gravel. These are shallow soils (50-100 mm) underlain by hard or slightly weathered rock.

**Figure 5: Photo taken at soil unit Gra3, photo point BD19**

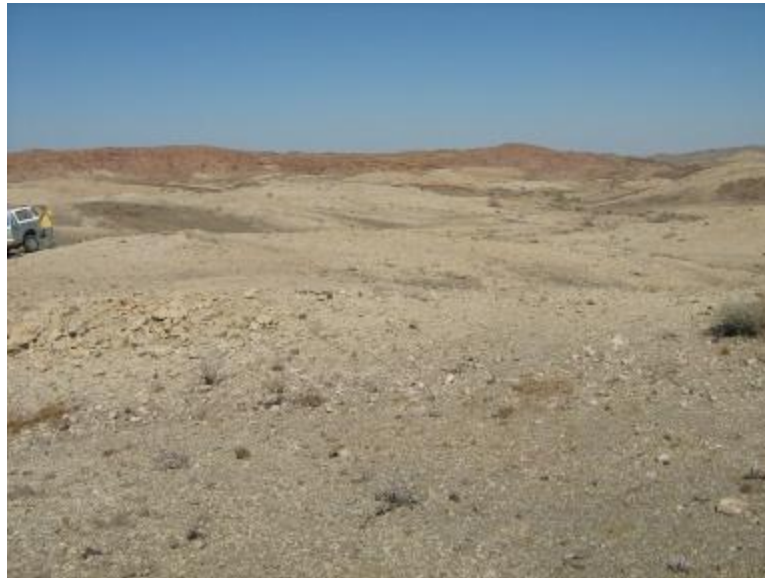
Soil unit **Qs** consists of mild to steep rolling quartzite outcrops (2-5% exposed surface rock) with frequent linear schist bands and comprises 15.47% of the surveyed area. The soil surface is mostly covered with a thin layer (30mm) of quartzite gravel. These are shallow soils (50-100 mm) underlain by slightly weathered rock.

**Figure 6: Photo taken at soil unit Qs, sampling point AK9**

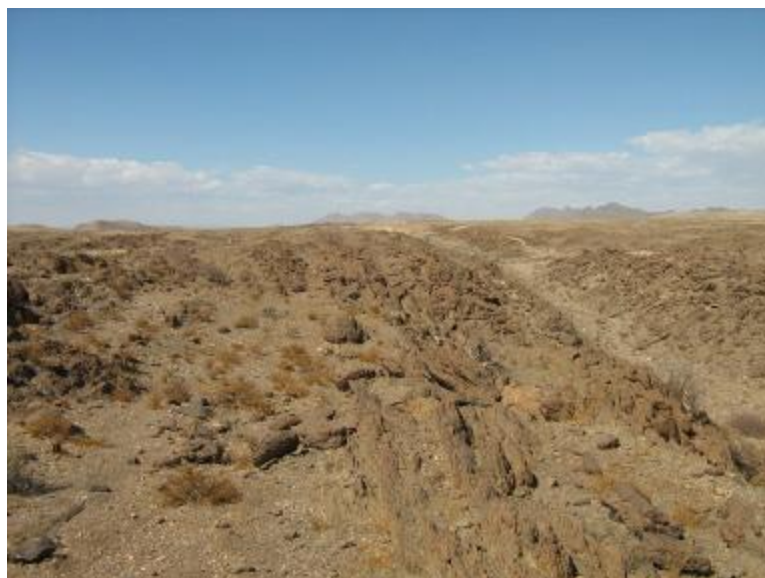
Soil unit **Sc1** consists of flat to slight undulating, narrow and wide bands of linear schist outcrops (tilted 30-80 degrees vertically) with 60-80% exposed surface rock and comprises 21.17% of the surveyed area. These are shallow soils (50-100 mm) underlain by hard or weathered rock dominated by the Mispah and Glenrosa forms.

**Figure 7: Photo taken at soil unit Sc1, photo point BH21**

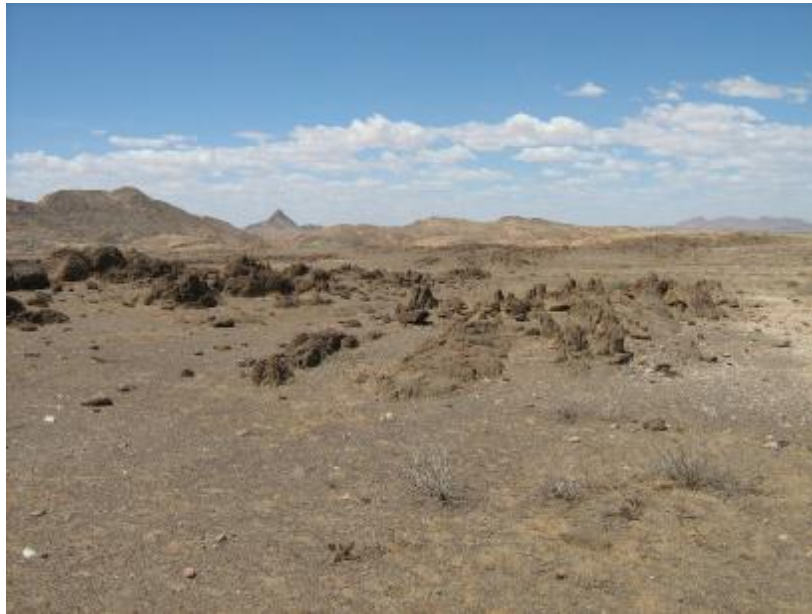
Soil unit **Sc2** consists of flat to slightly undulating, narrow and wide bands of linear schist outcrops (tilted 30-80 degrees vertically) with 5-20% exposed surface rock and comprises 4.18% of the surveyed area. These are shallow soils (50-100 mm) underlain by hard or weathered rock dominated by the Glenrosa form.

**Figure 8: Photo taken at soil unit Sc2, photo point BB22**

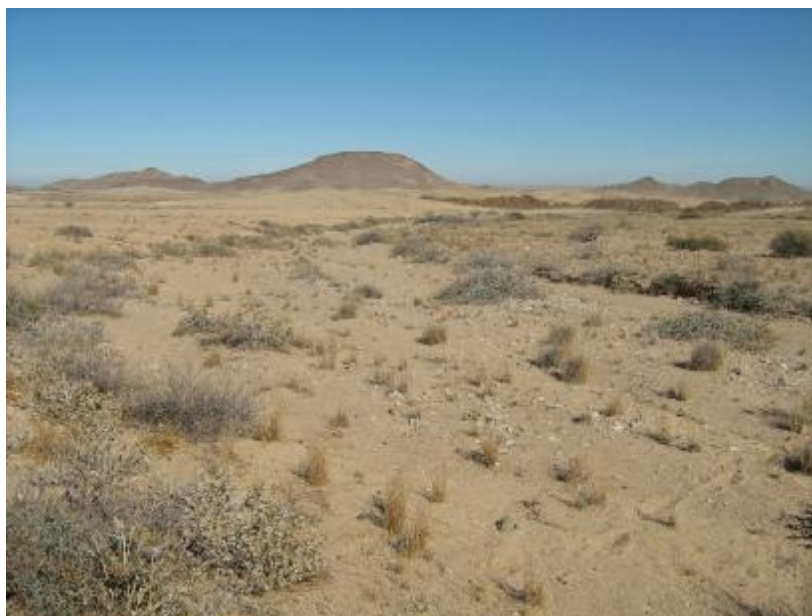
Soil unit **DZ** (drainage zones) consists of narrow, flat, dry streambeds with varying shallow to deep sandy soil deposits and comprises 4.31% of the surveyed area.

**Figure 9: Photo taken at soil unit DZ, sampling point AS22**

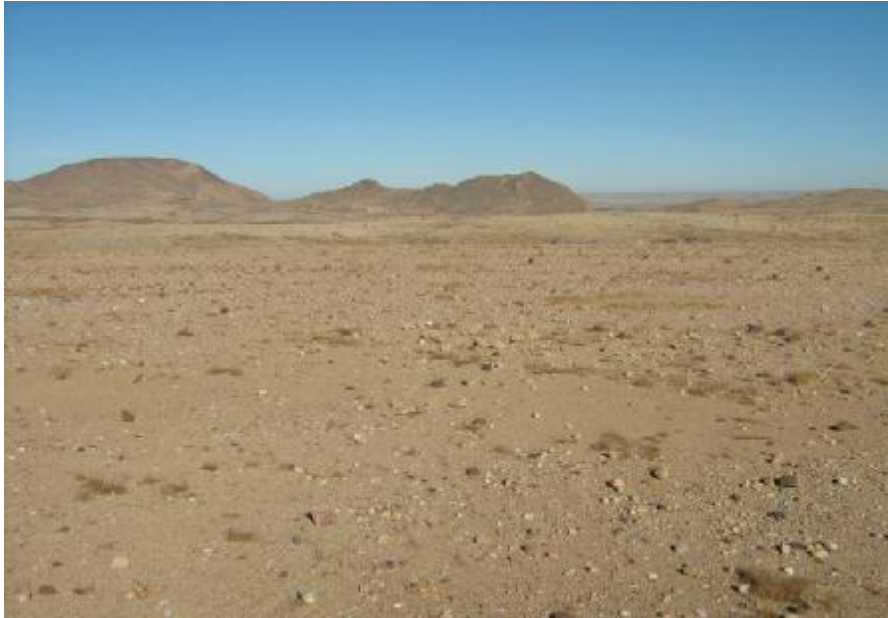
Soil unit **Co1** consists of flat to slight rolling, medium to coarse grained colluvial and alluvial material and comprises 4.62% of the surveyed area. Very little soil geneses was evident in this unit and hence it was not classified into a soil form.

**Figure 10: Photo taken at soil unit Co1, sampling point AE10**

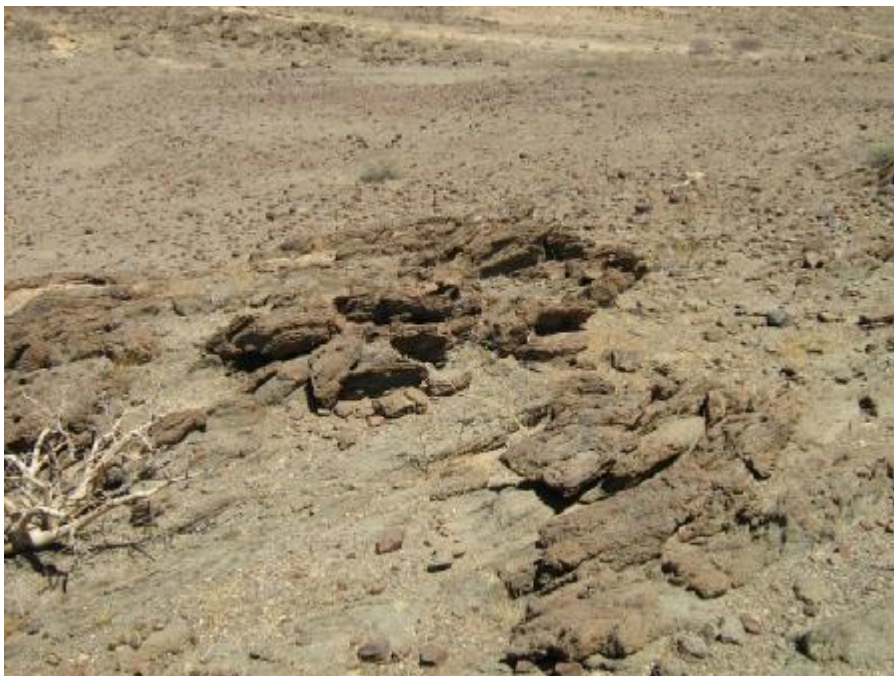
Soil unit **E** consists of areas subject to severe erosion within the generally high eroded landscape and comprises 8.06% of the surveyed area.

**Figure 11: Photo taken at soil unit E, photo point BC25**
